Drop Test Results for the Combustion Engineering Model No. ABB-2901 Fuel Pellet Shipping Package

R. Hafner, G. Mok, and L. Hagler

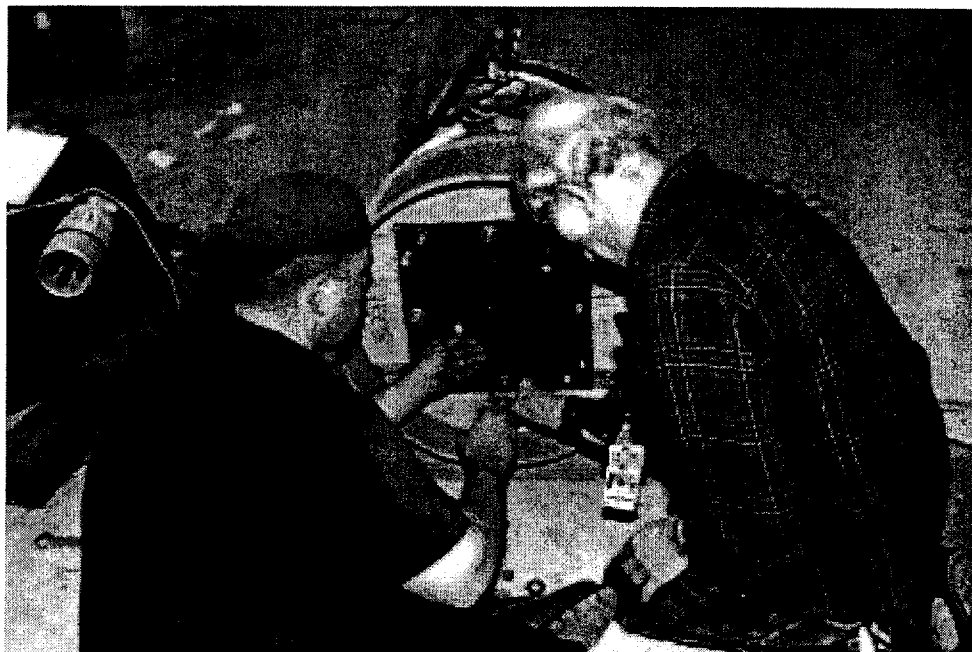
**Figure 13. Containment Closure, Bldg. 836C
From left, Rich Villafana (LLNL) and Bruce Clegg (LLNL)**

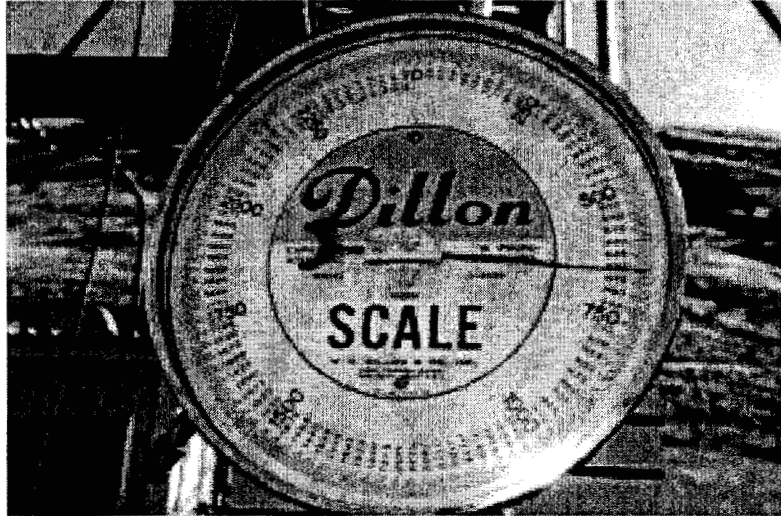
Figure 14. Packaging Weighing, Bldg. 858

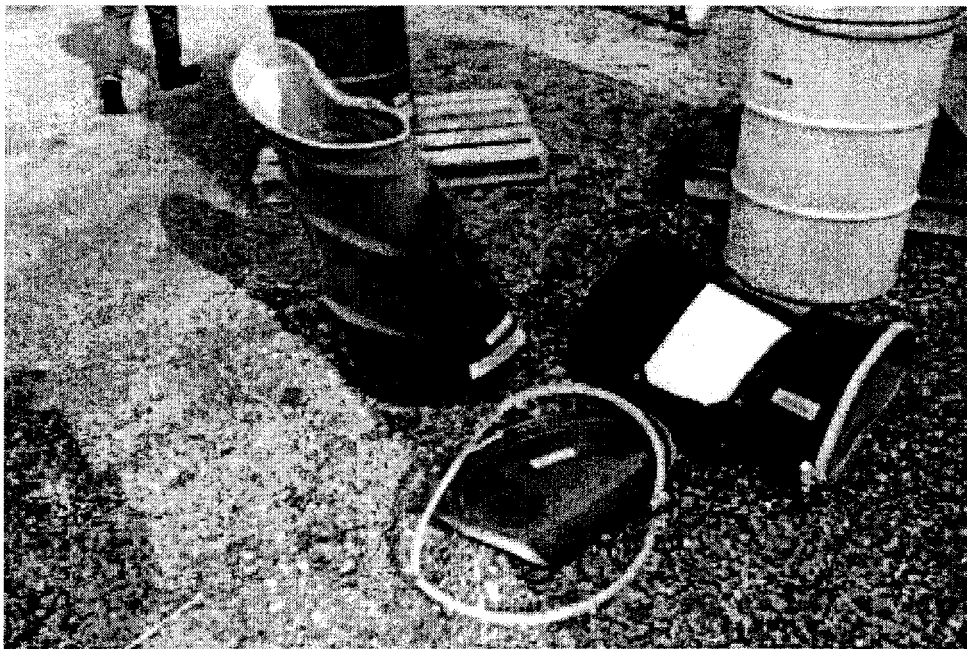
Figure 20. Damage to Lid, Closure Ring and Drum Along Side of Damage to Previously Dropped 35-Gallon, Water-Filled Drum

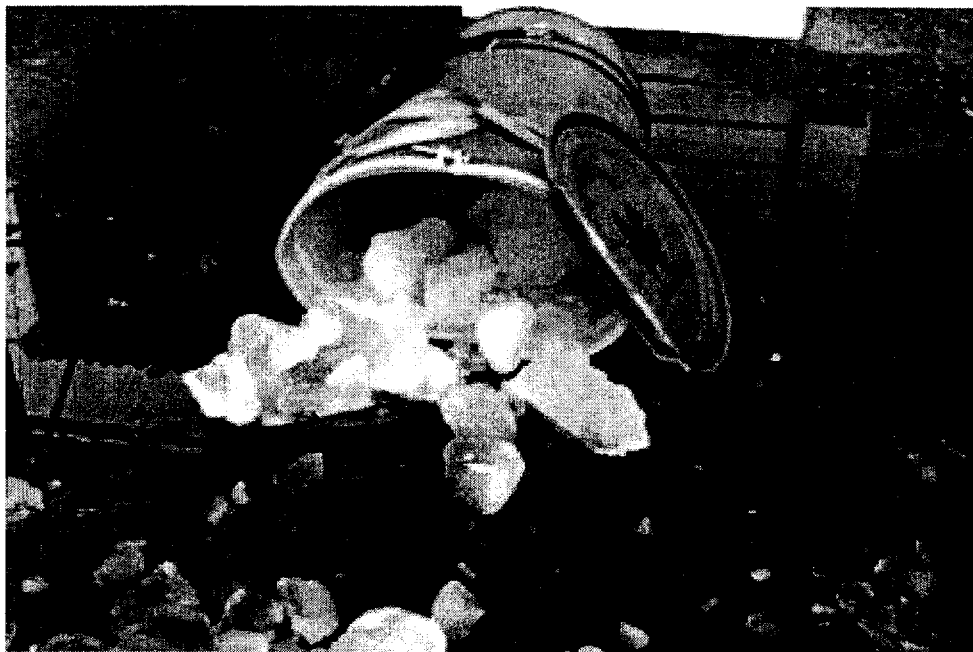
Figure 21. Damage to Drum and Lid after Ice-Filled Drop (Close-Up) (I)

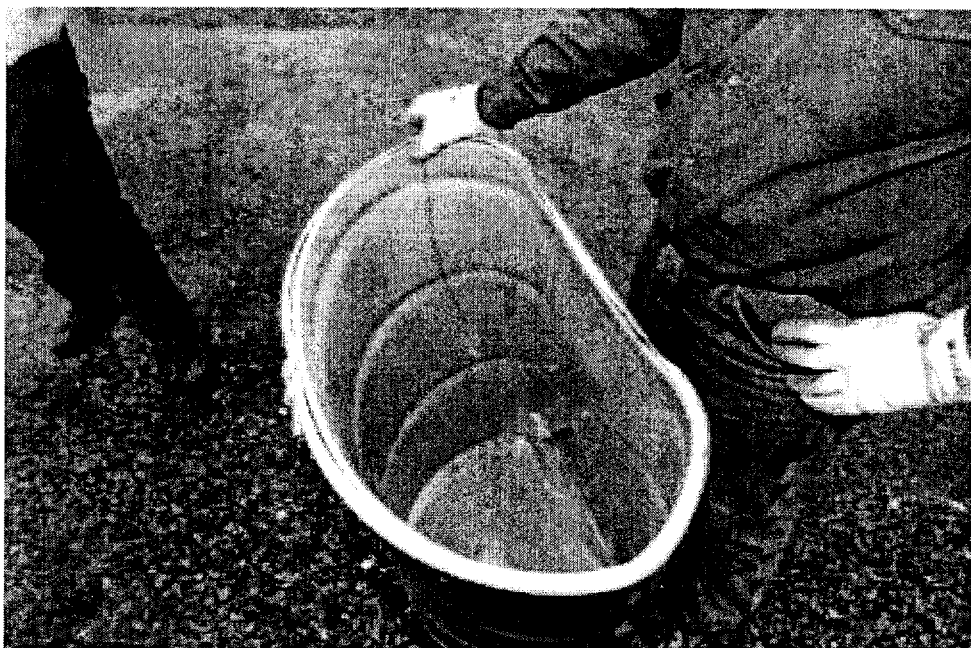
Figure 22. Damage to Drum (Ice-Filled Drop)
Rich Villafana (LLNL) and Jesse Rivera (LLNL)

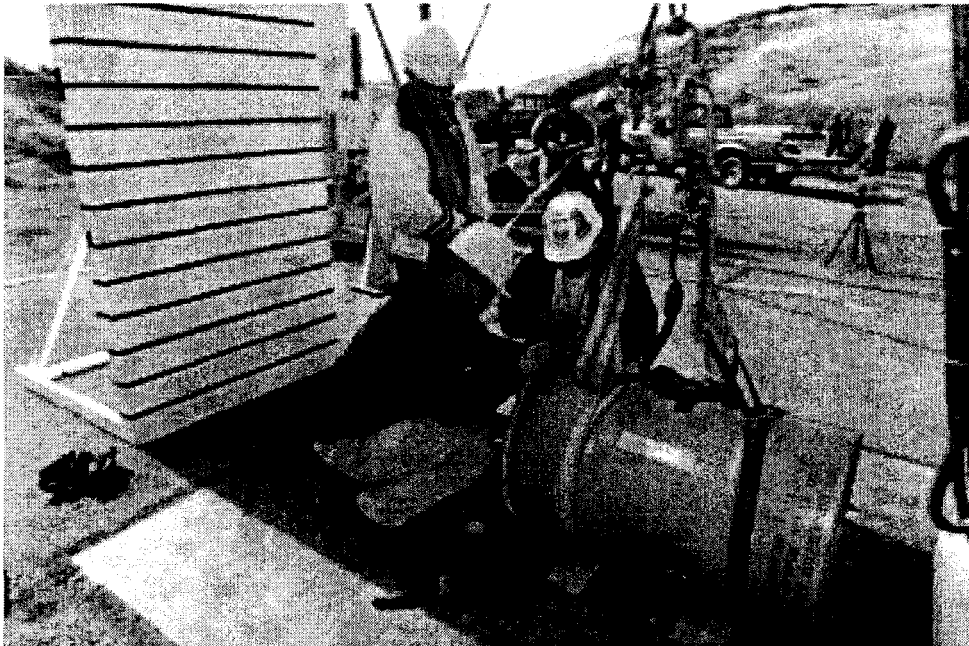
Figure 24. Packaging Closure, Bldg. 858

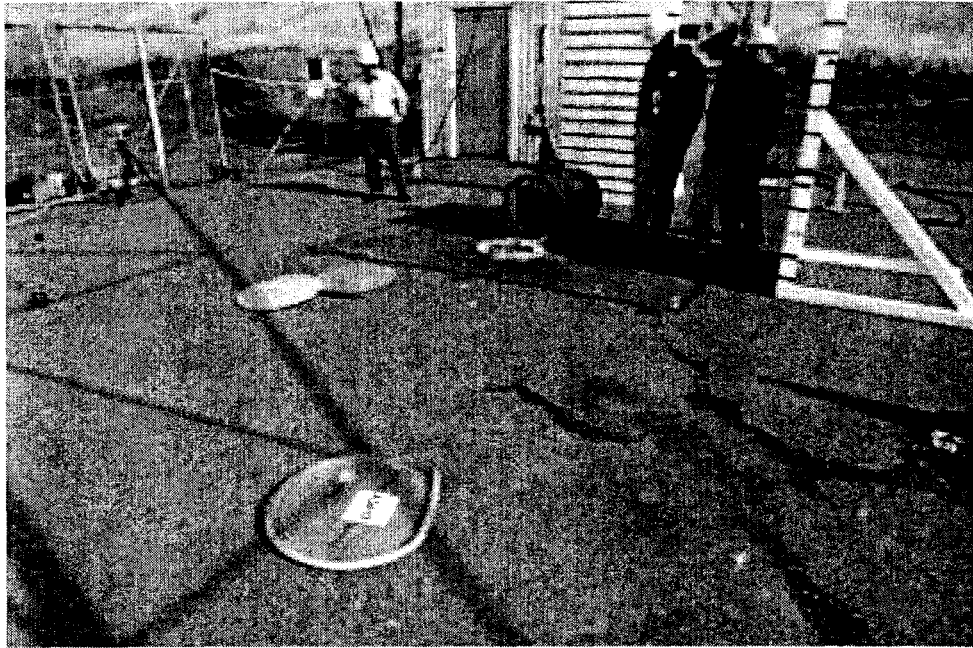
Figure 27. Post-test Component Orientation (Wide-Angle View)
From left, Jesse Rivera (LLNL), Rich Villafana (LLNL), Tom Woehrle (LLNL), and Bruce Clegg (LLNL)
